Case from Dr Dominic O'Hooley,  
United Kingdom

## Immediate Placement and Load for Compromised Incisor

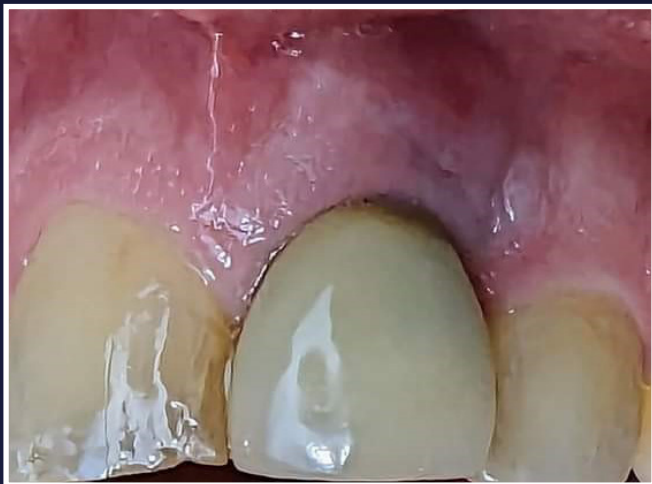
1. Initial situation

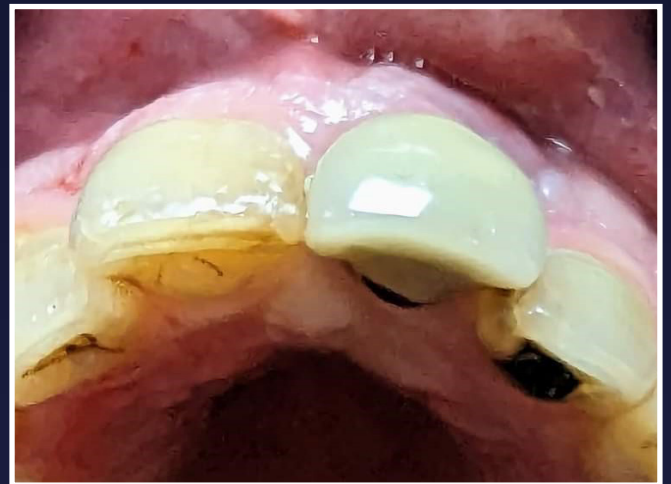
2. Showing ridge form

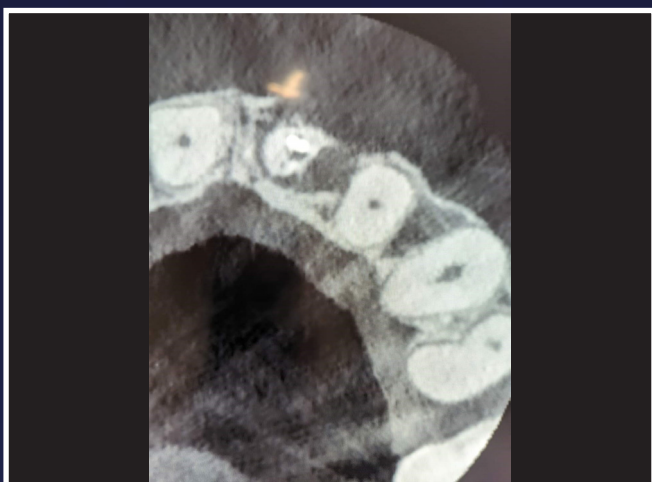
3. CT slice showing extent of defect

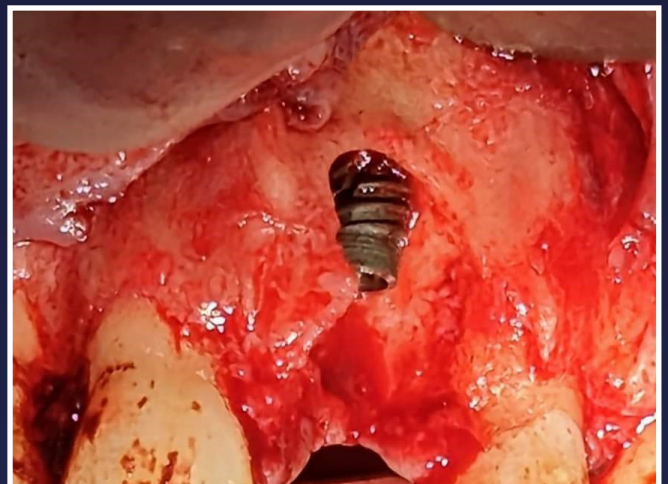
10. Showing depth of placement

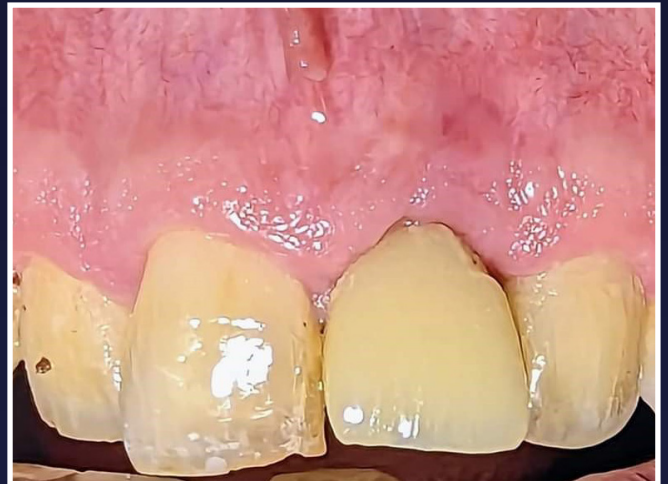
20. 8 week review

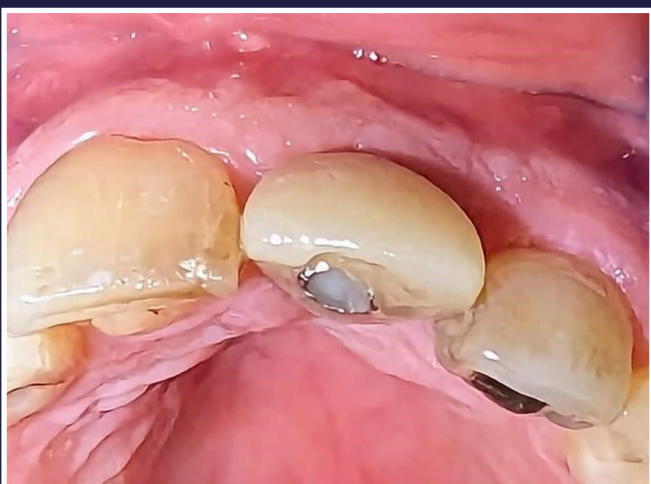
21. Showing ridge form at 8 weeks post placement
